## Talisman Galley: Flexible Riser Damage

The Galley field is a Talisman Energy owned asset in Block 15/23a of the North Sea. The field is exploited via 6 flexible risers and an umbilical tied back to the Northern Producer semi-submersible FPU operated by Petrofac Facilities management.

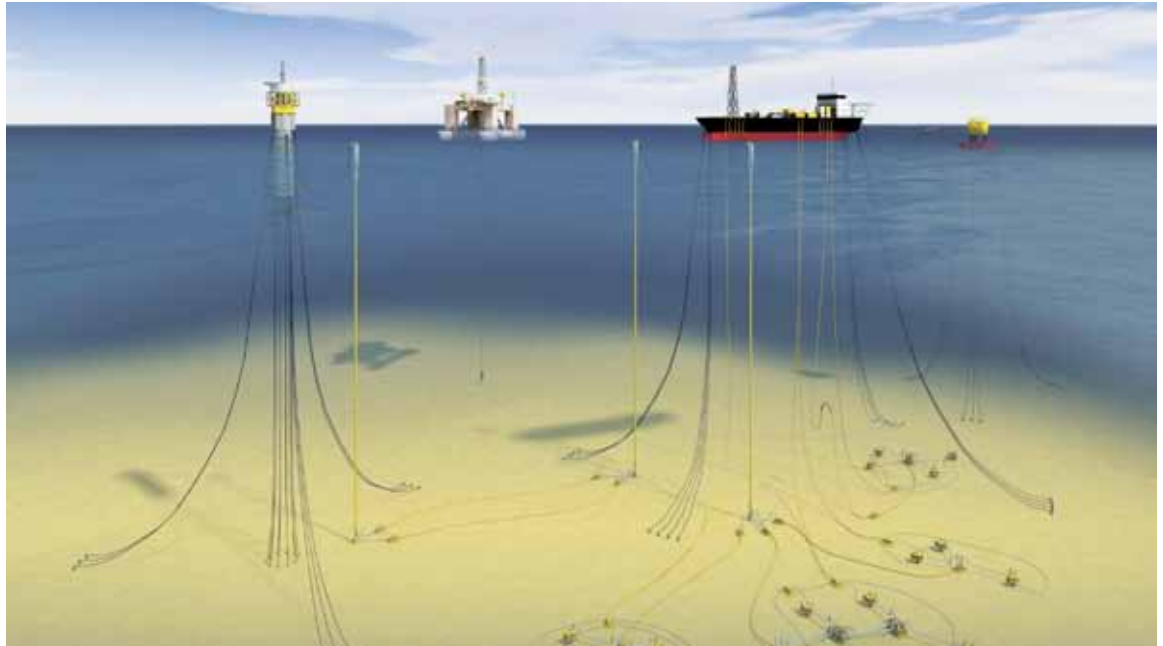
Routine GVI of the riser system indicated potential damage to the Gas Export riser, observed as a steady stream of gas bubbles emanating from an inverted riser bellmouth guide.

With the inability to inspect the riser within the inverted bellmouth the root cause of the damage was unknown. Therefore the riser was isolated and raised to allow inspection of the damaged section. This inspection found structural damage to the outer layers of the flexible pipe caused by mechanical wear against debris in the bellmouth and leading to erosion-corrosion damage of the outer tensile armour wires.

The principal remedial measures comprised the change in riser service from gas export to water injection supporting temporary operations prior to permanent repair of the riser. The permanent repair of the riser involved recovering over 30m to deck without compromising the riser configuration; the cutting of the damaged section from the riser length; reconnecting the cut faces; and reinstallation.
