### TALISMAN GALLEY: FLEXIBLE RISER DAMAGE

The Galley field is a Talisman Energy owned asset in Block 15/23a of the North Sea. The field is exploited via 6 flexible risers and an umbilical tied back to the Northern Producer semi-submersible FPU operated by Petrofac Facilities management.

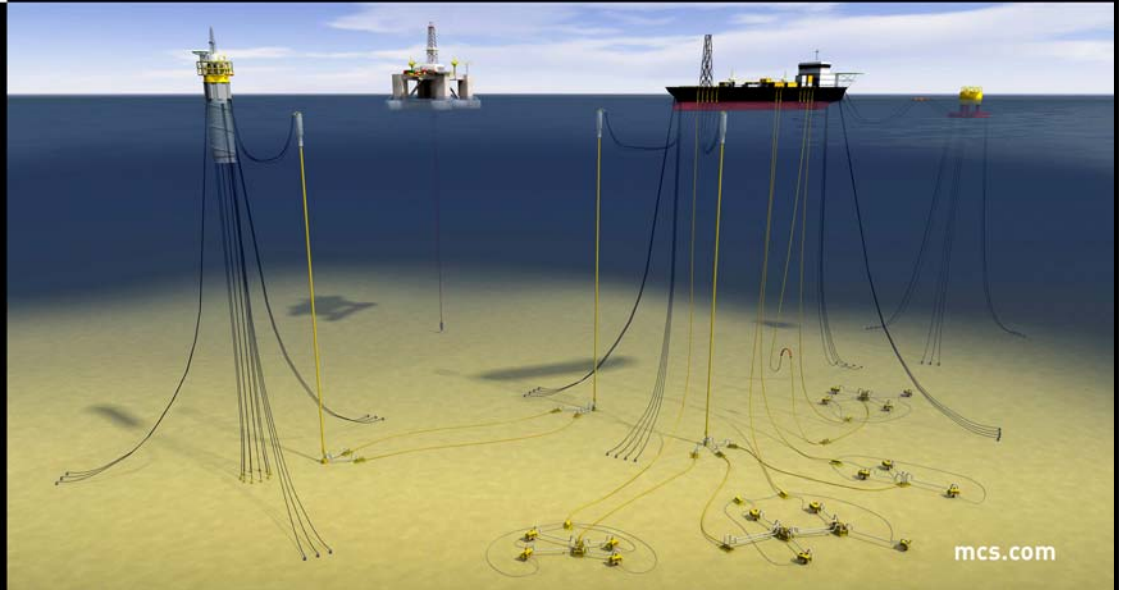
Routine GVI of the riser system indicated potential damage to the Gas Export riser, observed as a steady stream of gas bubbles emanating from an inverted riser bellmouth guide

With the inability to inspect the riser within the inverted bellmouth the root cause of the damage was unknown. Therefore the riser was isolated and raised to allow inspection of the damaged section. This inspection found structural damage to the outer layers of the flexible pipe caused by mechanical wear against debris in the bellmouth and leading to erosion-corrosion damage of the outer tensile armour wires.

The principal remedial measures comprised the change in riser service from gas export to water injection supporting temporary operations prior to permanent repair of the riser. The permanent repair of the riser involved recovering over 30m to deck without compromising the riser configuration; the cutting of the damaged section from the riser length; reconnecting the cut faces; and reinstallation.
